Abandoned Railroad Grade Culvert Collapse on Nebagamon Creek

Severe longstanding threat to the health Bois Brule River fishery

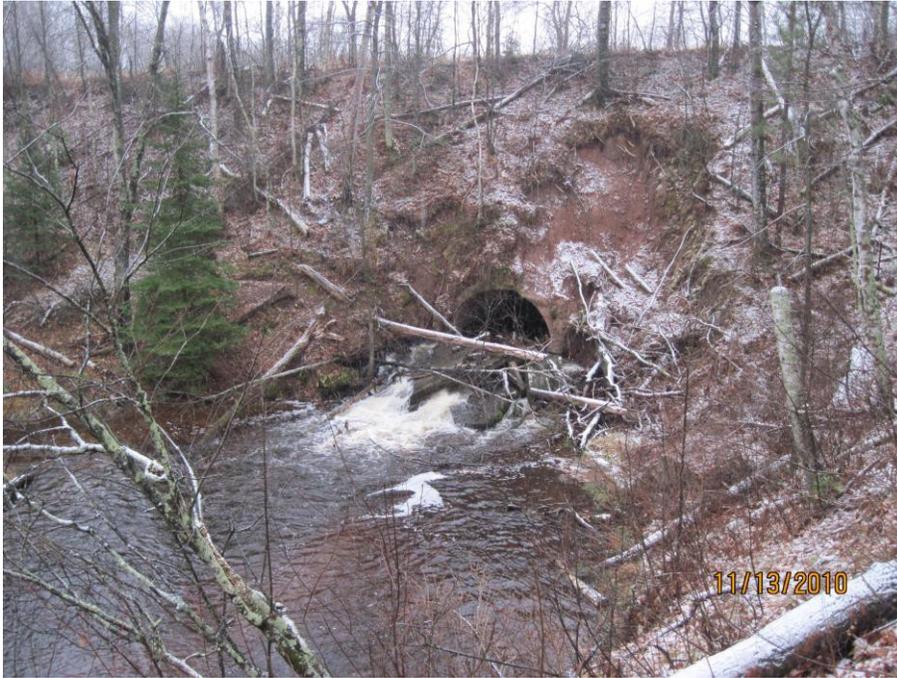
- Figure 2 illustrates the very high grade and the collapsed wing-walls with grade erosion beginning to take place.
- Figure 3 shows a close-up of the wing-walls lying in the outflow.

Figure 2. Wing-wall collapse at downstream side of culvert (Also note erosion of grade).

- Action needs to be taken as soon as possible before the following expected scenario occurs:
 - ✓ Culvert collapses and streamflow potentially becomes blocked completely.

This potential threat must be eliminated as soon as possible! The Brule Sportsmen's Club board suspects that if a landowner or responsible party has not been identified yet, we may need to take other action. We may need to seek private or state funding to remove the grade. The Brule Sportsmen's Club moved to seek immediate attention to this Bois Brule River fishery threat at the October 27th, 2014 meeting.

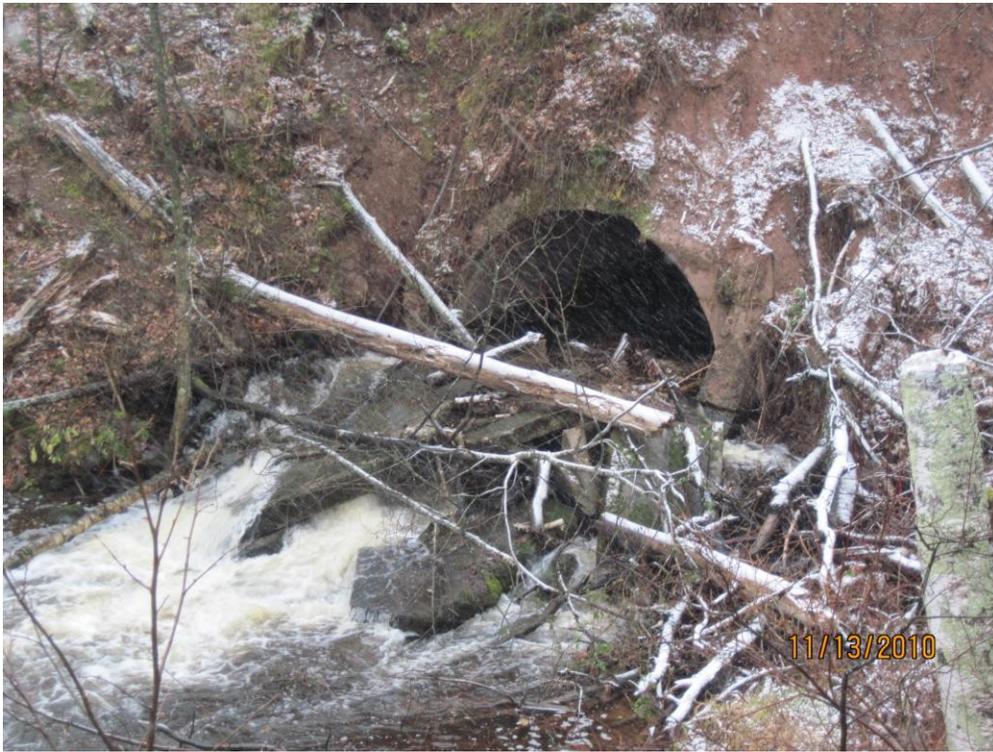
Figure 3. Close-up showing wing-walls entirely collapsed into stream.

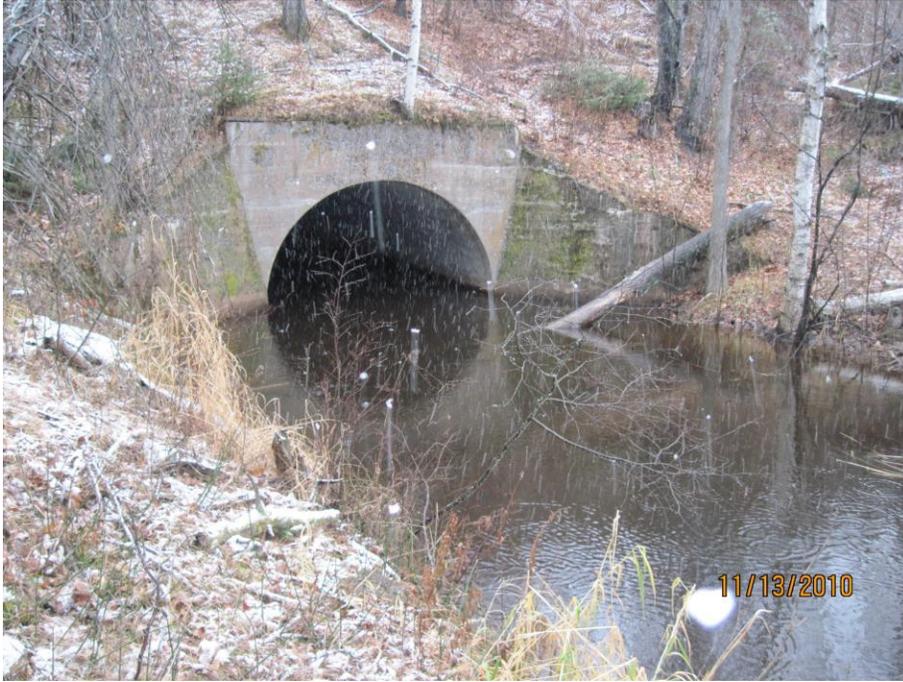
- Figure 4 shows the upstream end of the culvert with backed up water reducing the flow capacity of the culvert by about one-half.
- Although this issue was first noted in 2009, it has been brought to our attention that nothing has been resolved.

Figure 4. Culvert impounding water on upstream side of culvert.
