Rocky Run
DNR/Brule River Sportsmen's Club trout habitat restoration project

Project Description

Project to restore fish habitat on Rocky Run, Douglas County

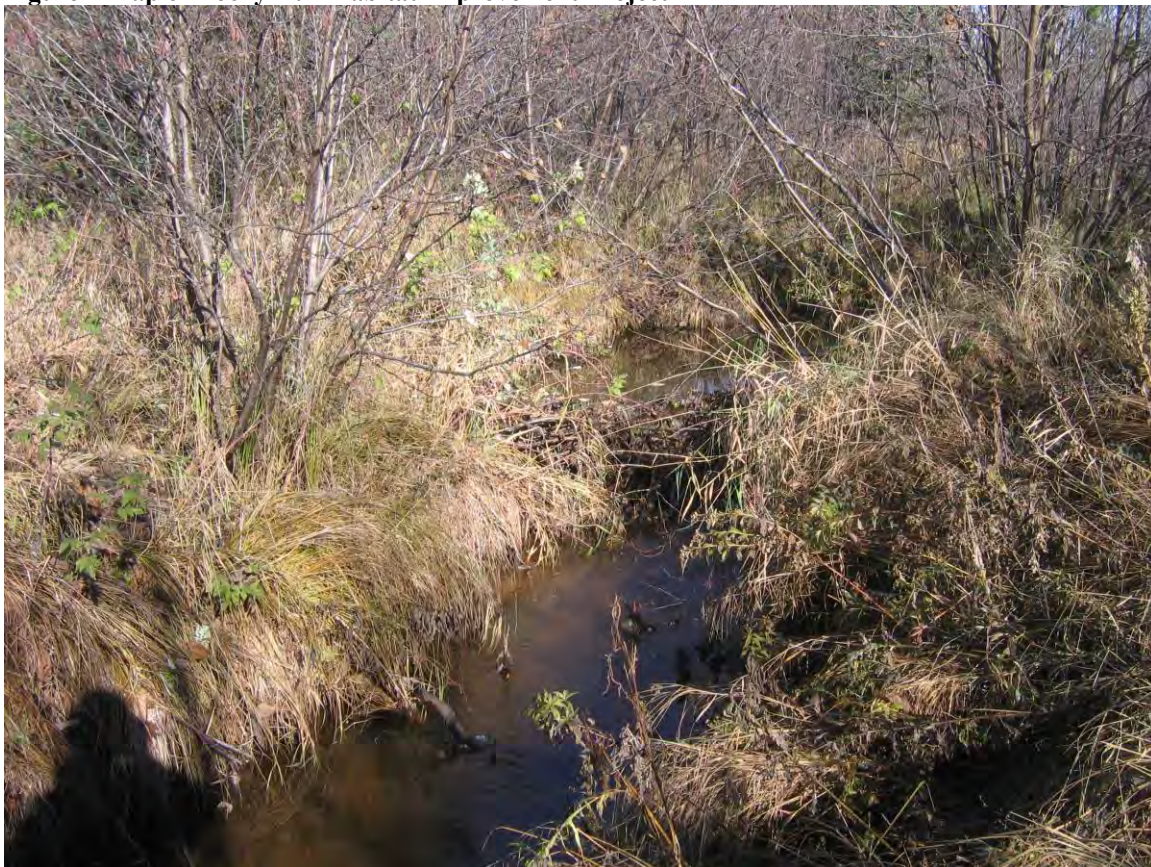
Figure 2 Rocky Run sand buried reach with old beaver dam footprint

This section historically contained an area of rocky gravelly bottom with many large logs that provided excellent trout spawning and living habitat. Today, the trout habitat of this reach of stream is fully to lightly buried in sand that had accumulated over the last century, exacerbated by beaver activity in the last three or four decades. The accumulation of bed load sand/silt has caused the water surface to rise and increased stream bank wetness creating a perfect condition for speckled alder to over grow the site (see attached photos). The combination of alder growth, beaver impoundment and the high-water table has limited the rehabilitation of a healthy stream side forest. Bank side alder tend to grow toward the sun or generally out and over the stream channel where they load with heavy winter snow and tip into the channel plugging with debris and then catching sand. Alder are a clump species and as stems of the clump tip into the stream the shrub simply replaces the dying stems with vertical shoots. The project objective is to hand remove the small woody debris (mostly dead alder stems) holding the bed load sand in place and cutting the stream side alder at the bank and within thirty feet of the bank (the distance that a mature alder can tip into the channel). Old beaver dam footprints will also be removed from the bed of the stream. Once the sand/silt binding material and beaver dams are hand removed by Brule River Sportsmen's Club volunteers the materials will gradually move downstream re-exposing the natural stream bed and any buried logs that remain. Brule River Sportsmen's Club volunteers will visit the site multiple times over the next couple of seasons continuing the hand removal process. Trained DNR staff will cut the bank side alder as needed along with the in-stream project work and suppress individual alder clump re-growth with an aquatic herbicide. Once the bank wetness subsides as the water surface falls, the Sport Club could return in following years to plant evergreens (likely white spruce) in areas too far away from natural seed sources to jumpstart the riparian forest succession which will eventually limit future alder re-growth (alder are an early successional stage tree specie that does not do well in a shaded condition of a healthy evergreen forest). Logs may be added to improve channel structure and provide trout overhead cover in future years. The Brule River Sportsmen's Club/DNR has gained landowner permission to do this work. Once the project is completed over the next couple of years, DNR fisheries staff will annually monitor and maintain the restored condition.

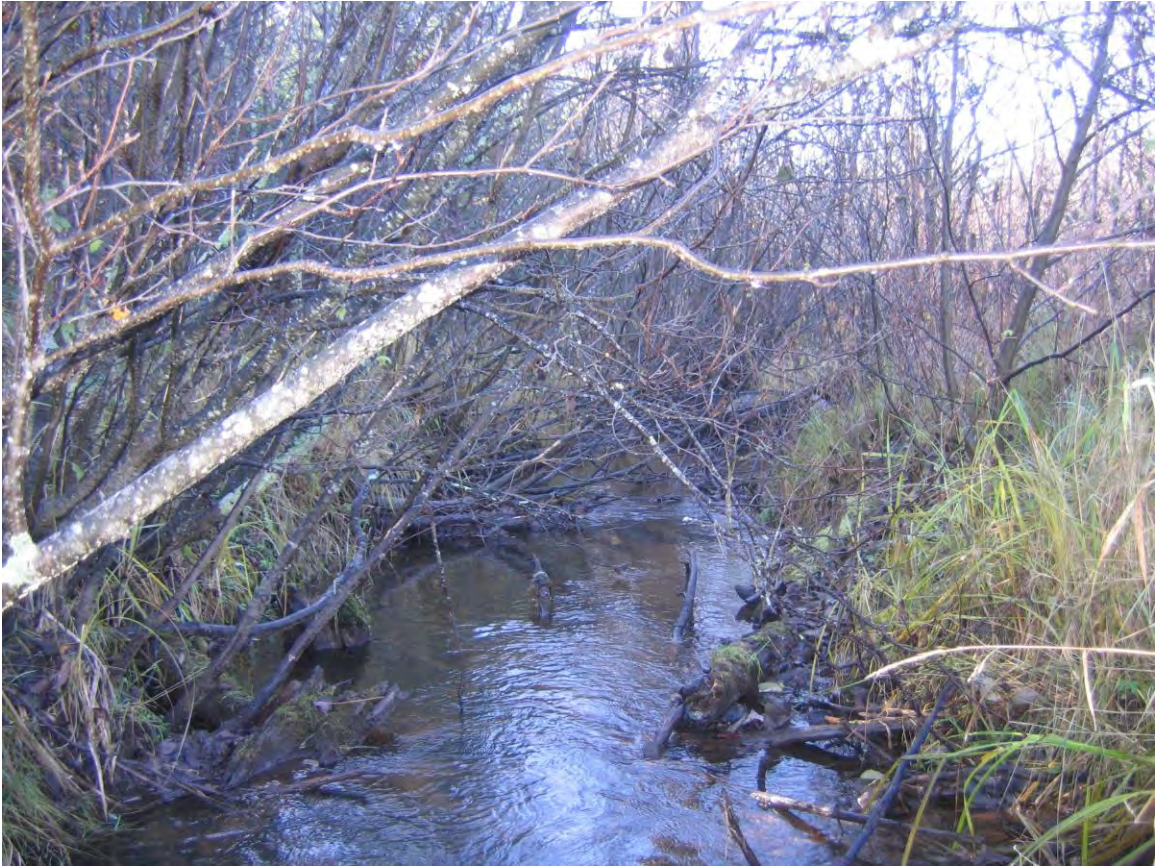
Figure 3 Rocky Run showing alder tipping problem

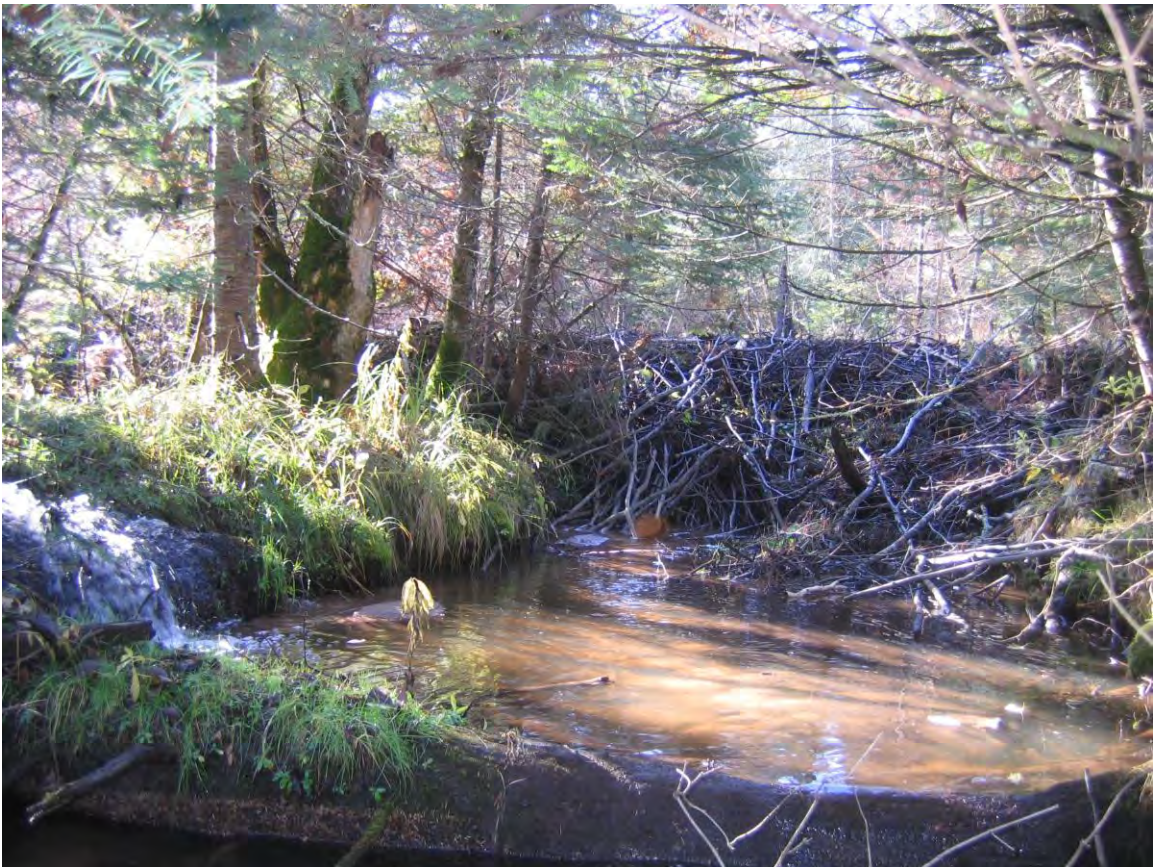
Figure 4 Downstream most beaver dam
